# Asset Management

## Updates to Emergency Resolution: Emergency Construction Services for the Repair of Dangerous Conditions

Facilities Planning & Management  
August 21, 2025

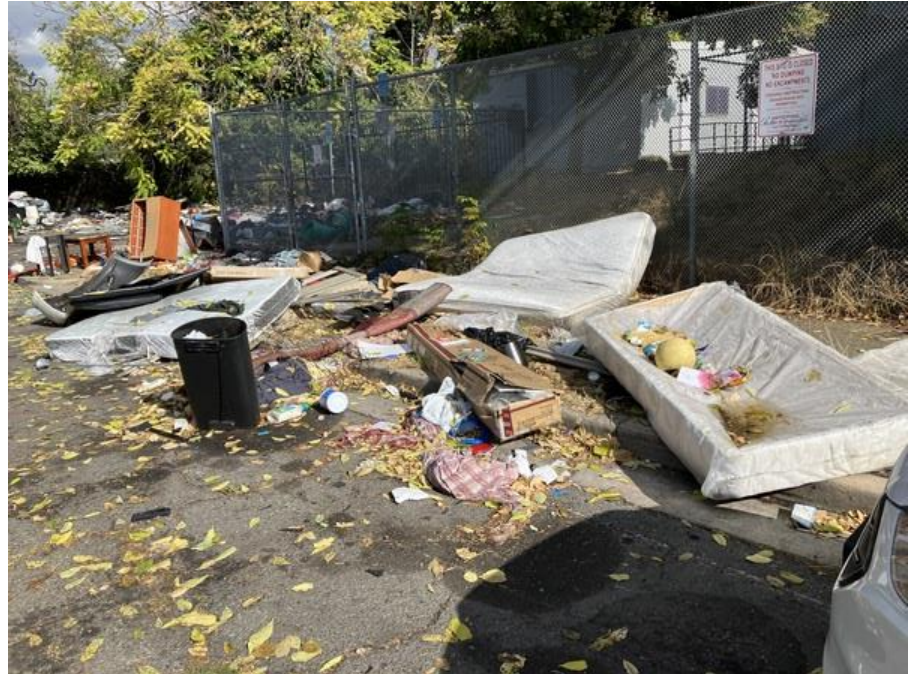
November 2024 - OAK 311

Trash and abandoned vehicles can be seen collecting along the street in front of the former Hillside Academy. Overgrown grass and weeds. Damage to the exterior portable walls.

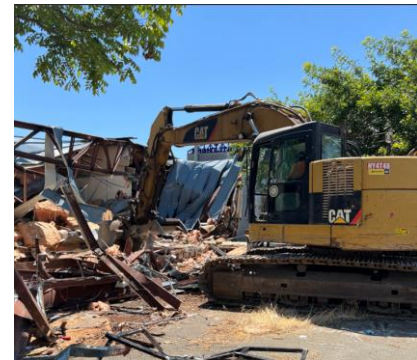
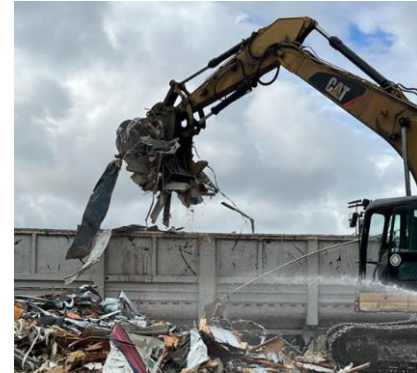
Initial Demolition and Separating Metals, Cement for Recycling *(Complete)*

- All structures demolished; debris fully removed as August 1, 2025
- Adjacent to Castlemont High School & Leadership Public Schools – enhanced safety for 1,000+ students
- Finished ahead of school start

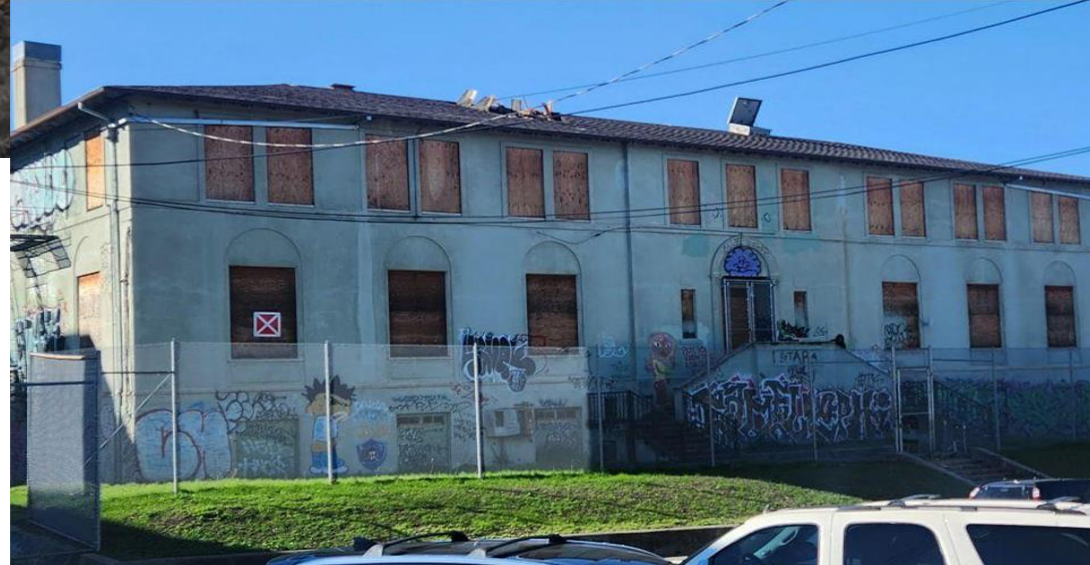
July 2024 - Morning after encampment fire, rear of  
building

- Sealing lower-level entry points with metal and stucco
- Removing fire escape to prevent unauthorized access
- Coordinating with city agencies to ensure compliance with safety protocols

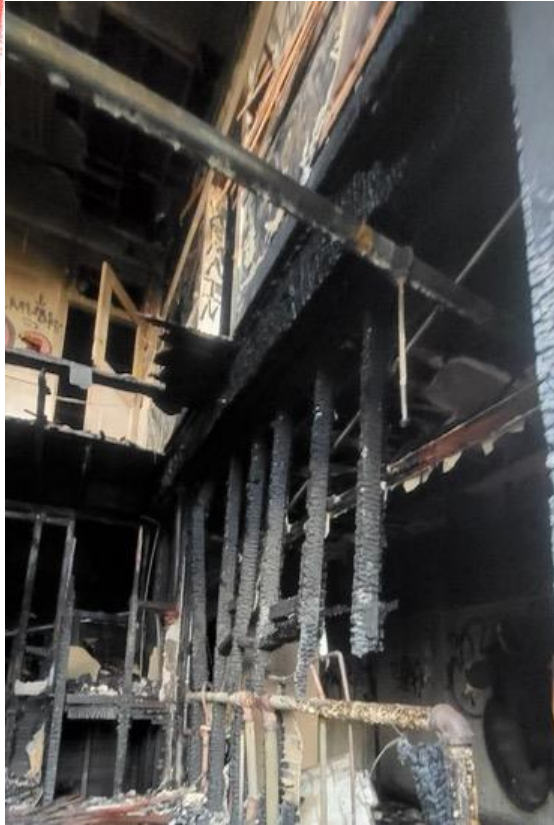
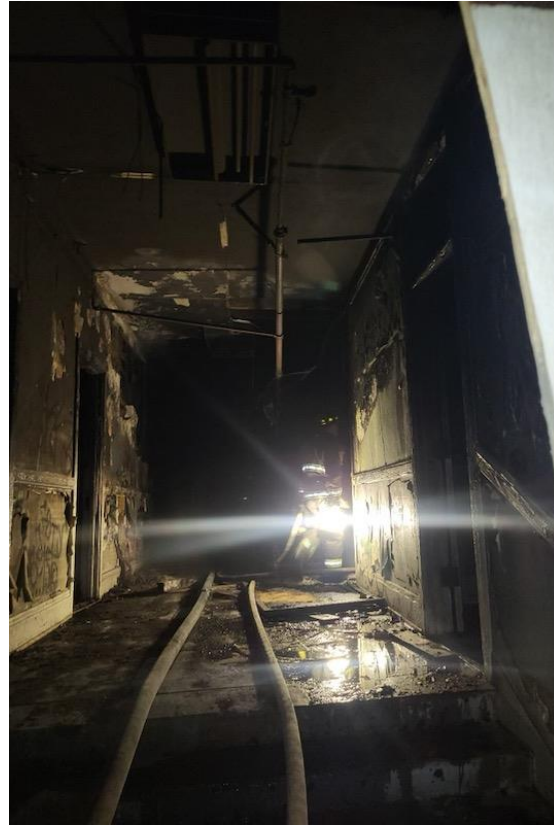
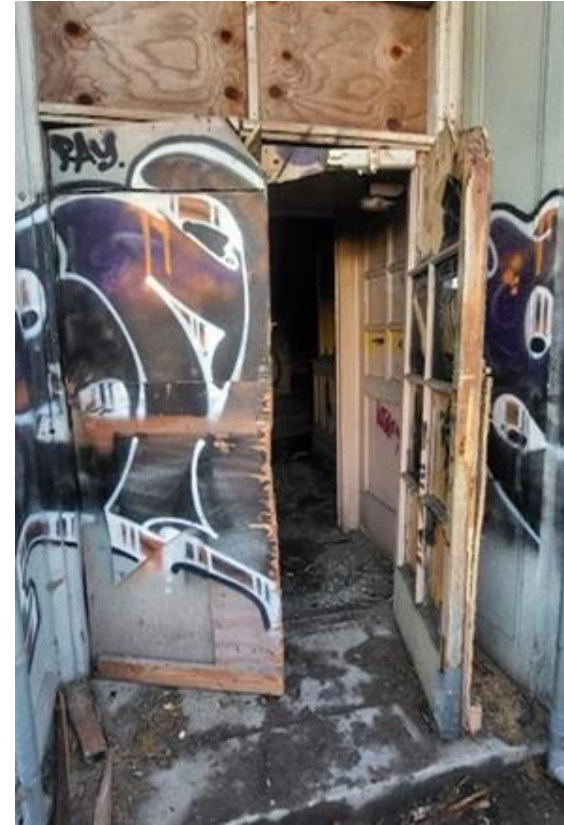
July 2024 - Interior of building after fire

- Sustained severe fire damage earlier this year; structural reports confirm extensive internal infrastructure loss
- Officially red-tagged by the fire department—building legally uninhabitable and unsafe to enter
- Assessment teams reported near-collapse risk on upper floors

- Complete structural soundness assessment
- Determine need for CEQA environmental review if demolition is pursued, given historical designation
