Asset Management

Updates to Emergency Resolution: Emergency Construction Services for the Repair of Dangerous Conditions

Facilities Planning & Management
August 21, 2025

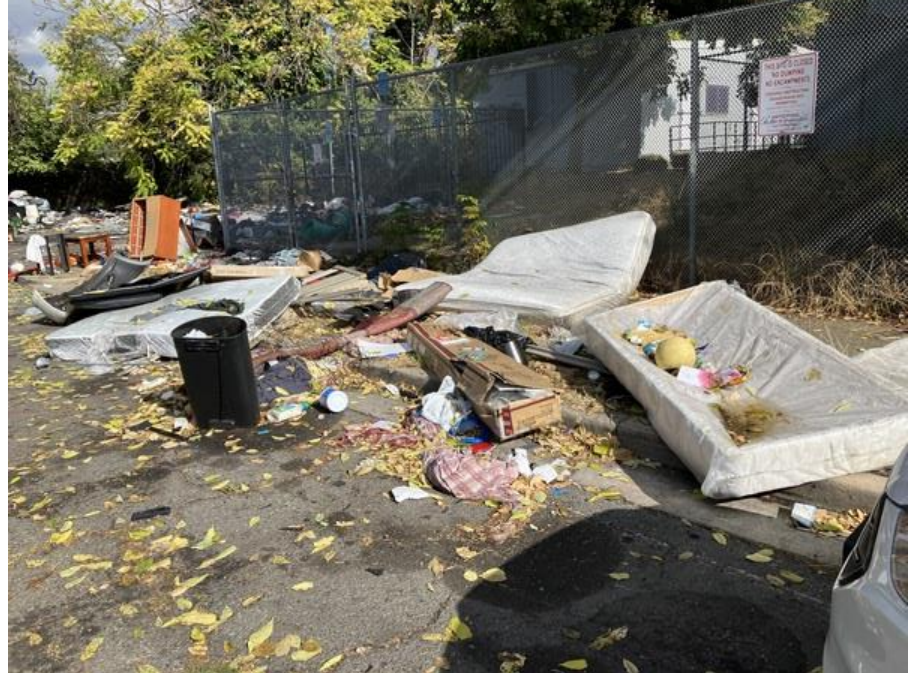
November 2024 - OAK 311

Trash and abandoned vehicles can be seen collecting along the street in front of the former Hillside Academy. Overgrown grass and weeds. Damage to the exterior portable walls.

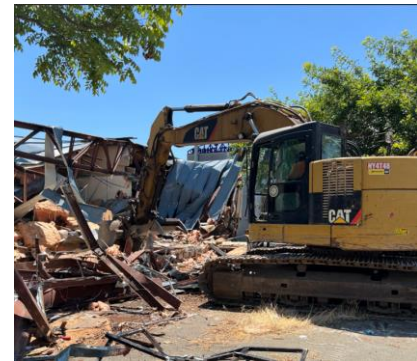
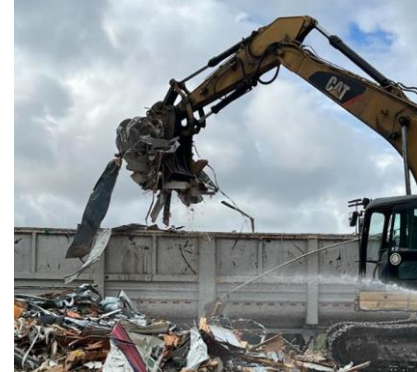
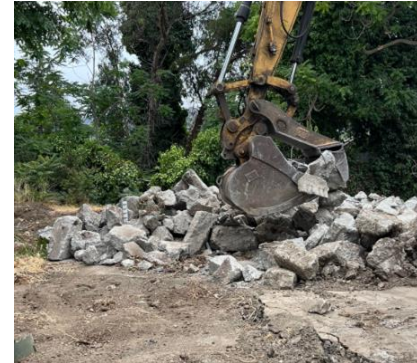
Initial Demolition and Separating Metals, Cement for Recycling *(Complete)*

- All structures demolished; debris fully removed as August 1, 2025
- Adjacent to Castlemont High School & Leadership Public Schools – enhanced safety for 1,000+ students
- Finished ahead of school start

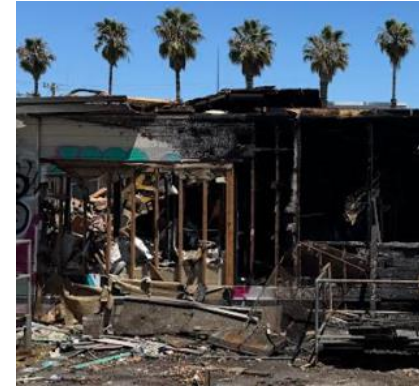
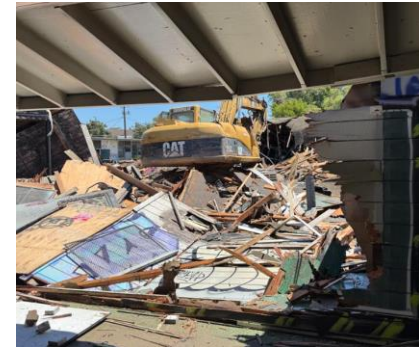
Hazmat Abatement and Beginning Demolition of the former Ralph Bunche Buildings

- Demolition activities underway
- Initial focus on abatement of asbestos, loose lead paint, and burned debris from fires disposed as hazardous materials
- Work follows all California Health & Safety Code and California Code Regulations requirements
- Based on age of the facility, abatement was required on one portable, requiring a specialized remediation plan that the Environmental Protection Agency (EPA)

- Abatement completed first, followed by full demolition
- Total project duration estimated at 3–4 weeks
