Subject Progress Updates - Resolution No. 2425-0132 Declaring an Emergency And Authorizing District Staff to Enter Into Contracts for Emergency Construction Services for the Repair of Dangerous Conditions at Various Sites Via Demolition of Existing Structures

Updates to Emergency Resolution: Emergency Construction Services for the Repair of Dangerous Conditions

Measures B, J, and Y Independent Citizens' School
Facilities Bond Oversight Committee
September 8, 2025

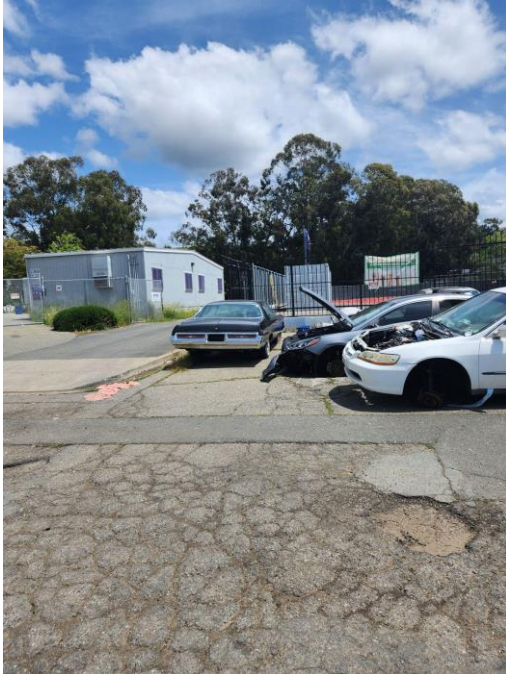
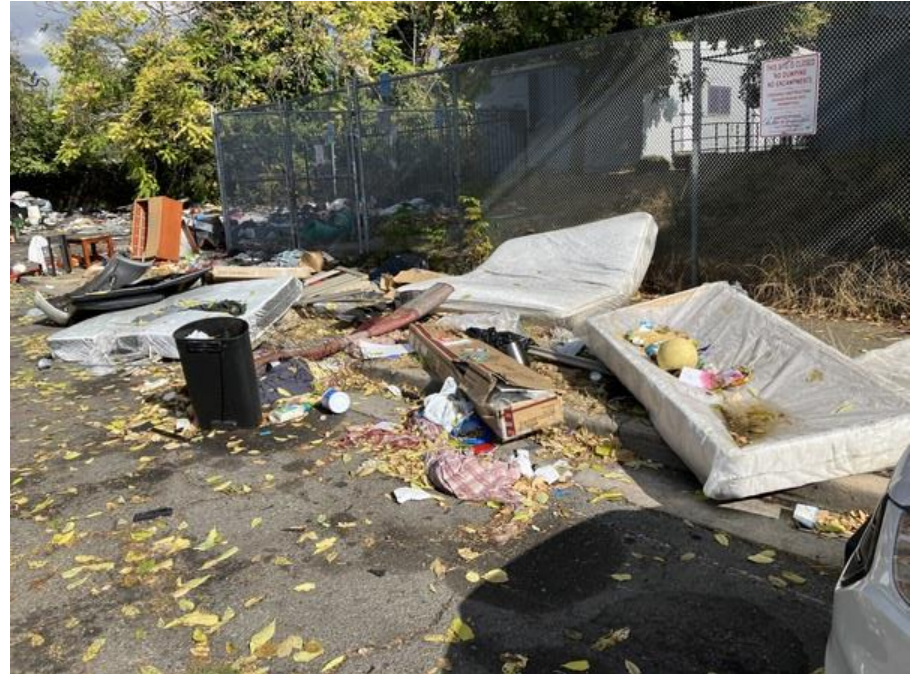
November 2024 - OAK 311

Trash and abandoned vehicles can be seen collecting along the street in front of the former Hillside Academy. Overgrown grass and weeds. Damage to the exterior portable walls.

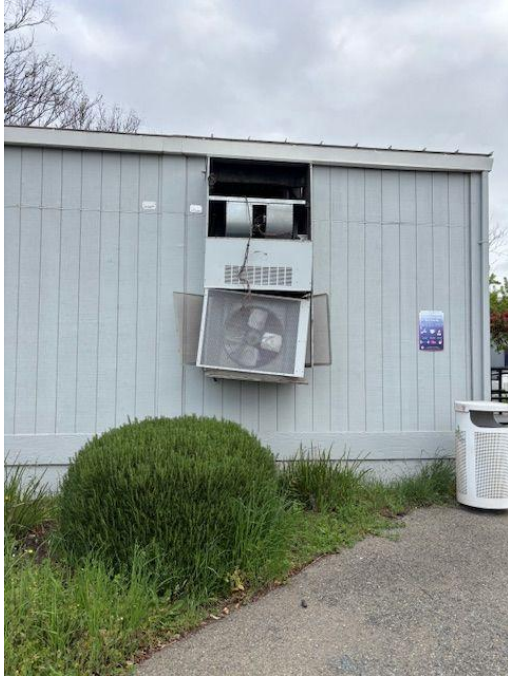
March 2025

All electrical lines, telephone, intrusion, and alarm system wiring have been removed, and most related equipment has been removed or damaged. Interior walls have been compromised, allowing access to every portable from the inside (classroom to classroom). Ceiling tiles and other items have been removed and destroyed throughout the portables.

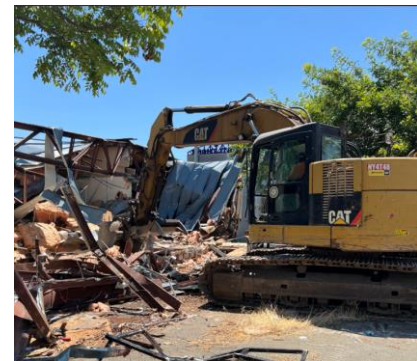
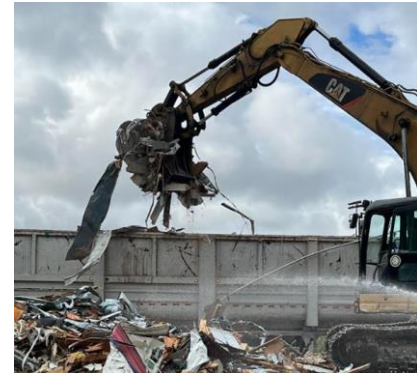
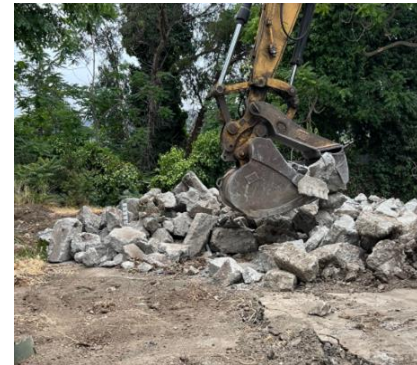
- All structures demolished; debris fully removed as August 1, 2025
- Adjacent to Castlemont High School & Leadership Public Schools – enhanced safety for 1,000+ students
- Finished ahead of school start

Initial Demolition and Separating Metals, Cement for Recycling (Complete)

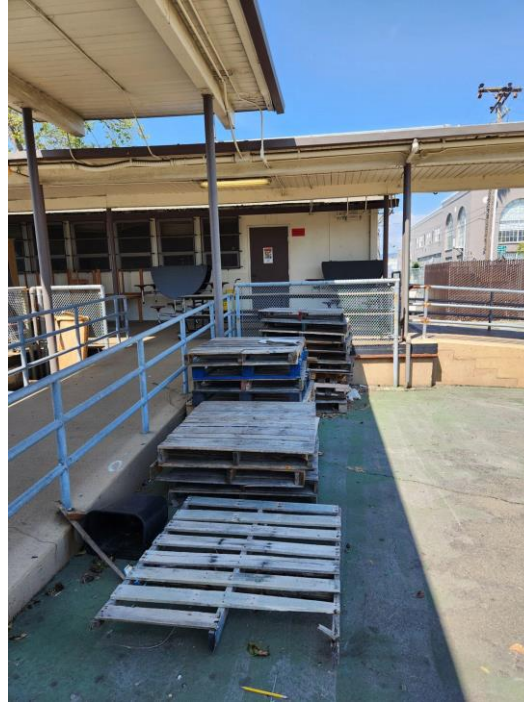
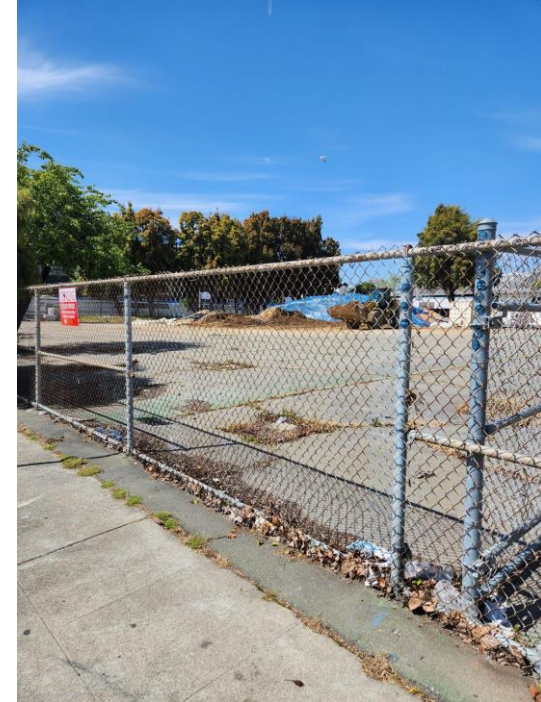
Graffiti now covers the buildings. The site is partly being used as storage.

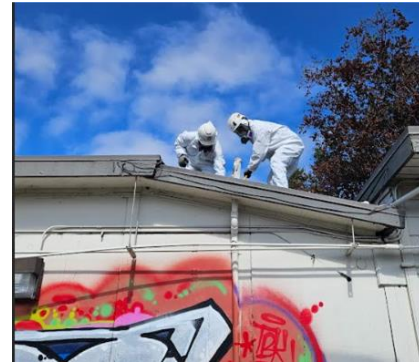
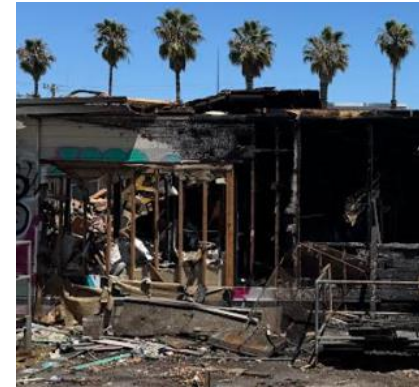
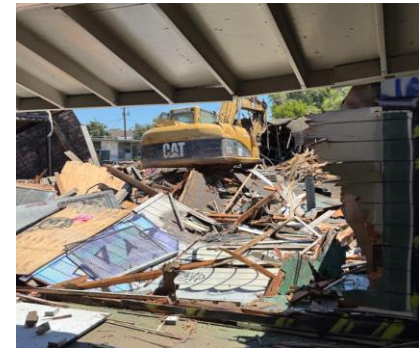
- Demolition activities underway
- Initial focus on abatement of asbestos, loose lead paint, and burned debris from fires disposed as hazardous materials
- Work follows all California Health & Safety Code and California Code Regulations requirements
- Based on age of the facility, abatement was required on one portable, requiring a specialized remediation plan that the Environmental Protection Agency (EPA)

Hazmat Abatement and Beginning Demolition of the former Ralph Bunche Buildings

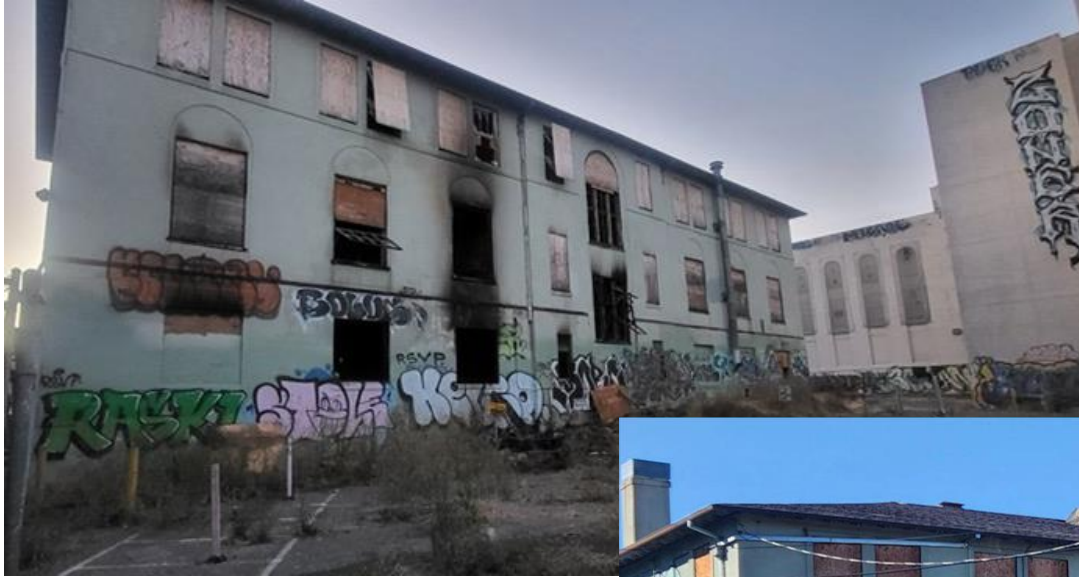
February 2025 - Front of building facing Dewey

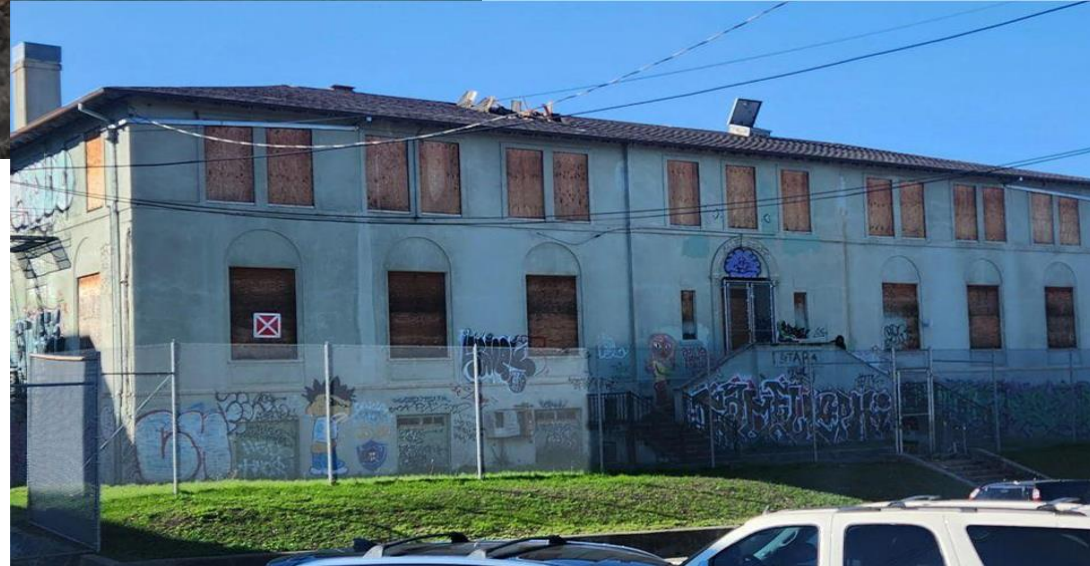
July 2024 - Morning after encampment fire, rear of building

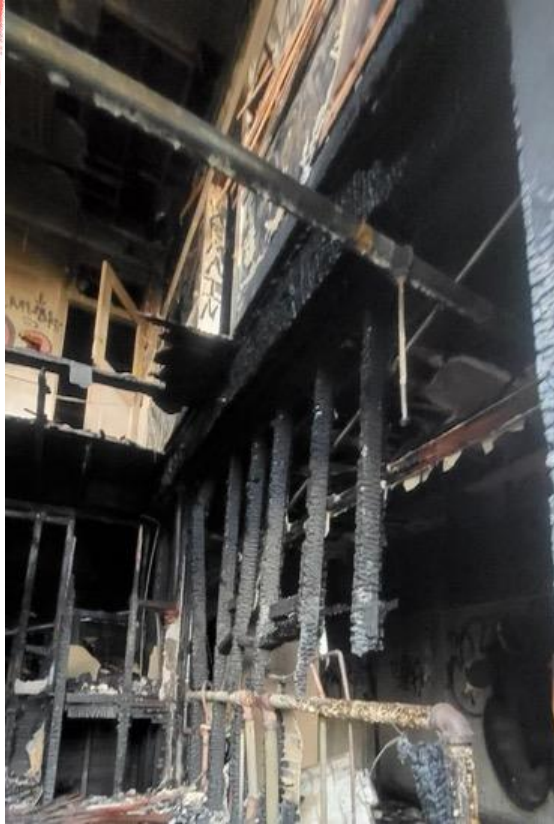
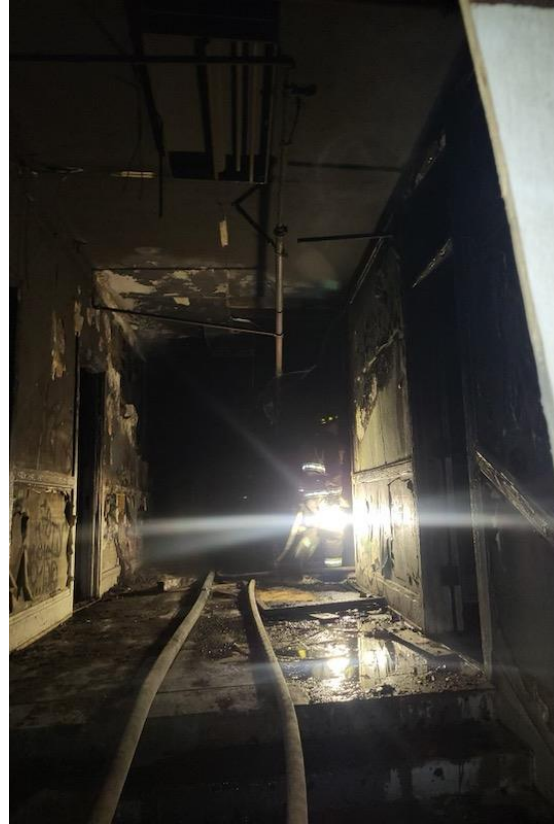
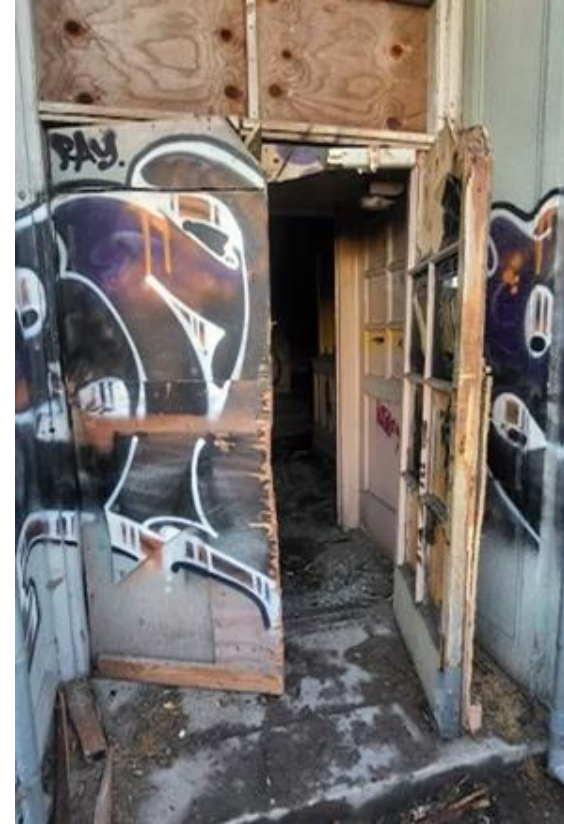
July 2024 - Interior of building after fire

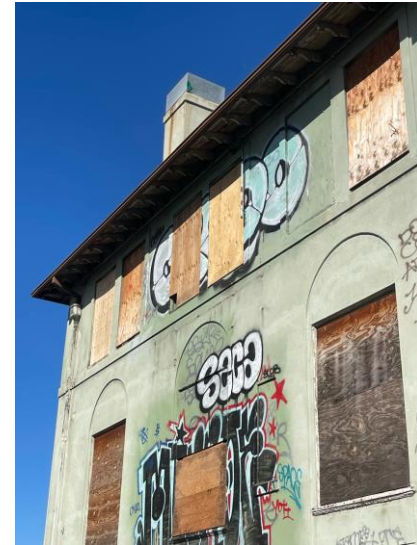
- Sustained severe fire damage earlier this year; structural reports confirm extensive internal infrastructure loss
- Officially red-tagged by the fire department—building legally uninhabitable and unsafe to enter
- Assessment teams reported near-collapse risk on upper floors

Fire damage and repair replacement recommendations

- Sealing lower-level entry points with metal and stucco
- Removing fire escape to prevent unauthorized access
- Coordinating with city agencies to ensure compliance with safety protocols
