OAKLAND UNIFIED SCHOOL DISTRICT

2026 FACILITIES MASTER PLAN

APRIL 2026

PERKINS —
EASTMAN

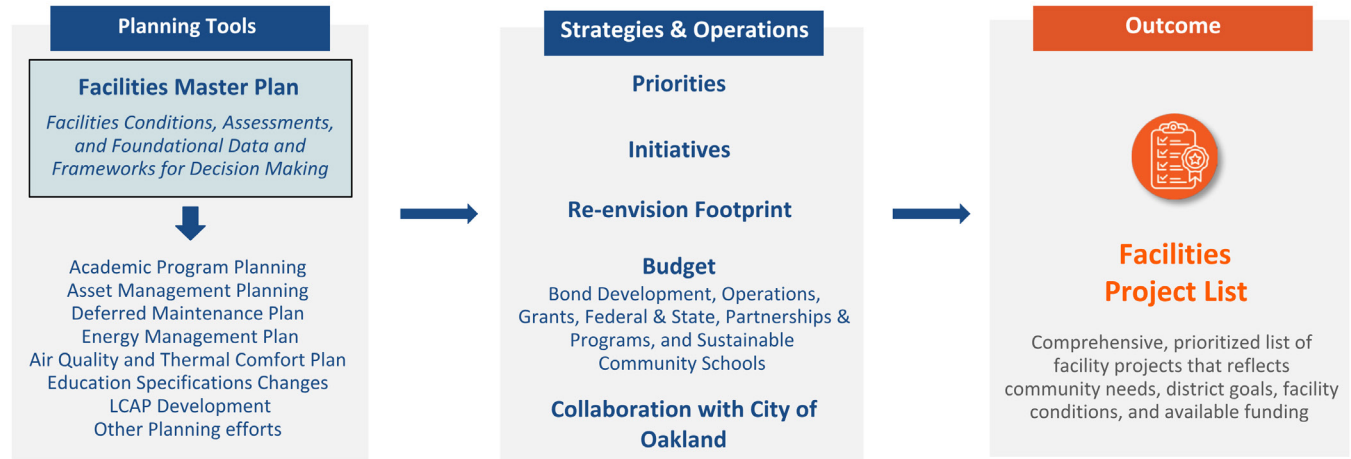
Figure 6 Planning Framework Process

Where does this FMP Fit in the Planning Framework

The FMP is the key bridge between vision and action—it compiles facility conditions, assessments, and foundational data, and provides a consistent framework for decision-making.

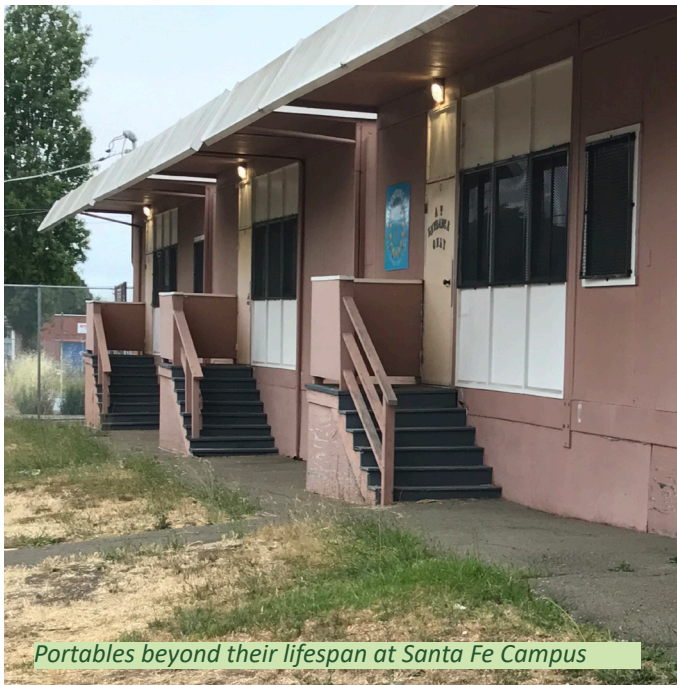
Portable classrooms often fall short of the quality provided by permanent school facilities, with both physical and operational constraints.

- Lower-quality learning environments: Poor insulation, inefficient HVAC, and exposure to noise and weather create less comfortable and effective spaces for teaching and learning

Portables beyond their lifespan at Santa Fe Campus

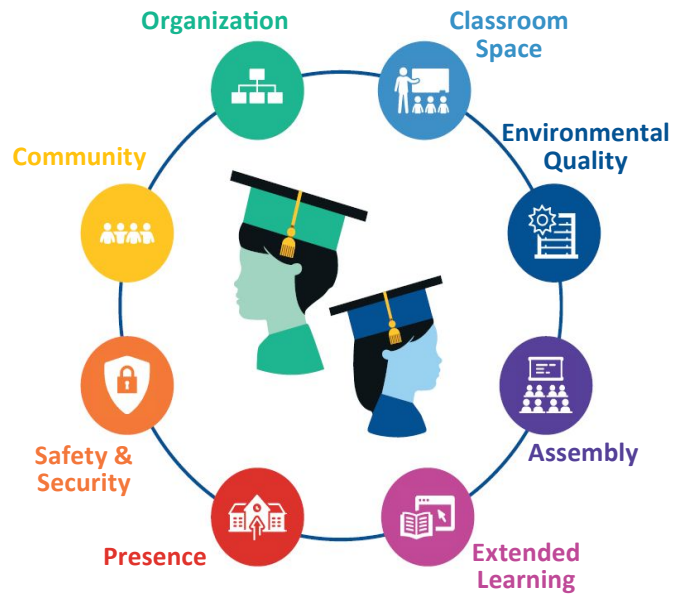
Figure 27 Education Adequacy Categories

- Adequacy gaps often reflect space quality and layout, not just building condition.
- Campuses may perform well in classroom space but lag in environmental quality, organization, extended learning, or support spaces.
- Inadequate classrooms (size, flexibility, acoustics, daylight) can limit instruction and student engagement.
- Missing collaboration, counseling, special education, arts, and STEM spaces can hinder academic and equity goals.
- The data reinforce that even buildings in acceptable physical condition may be educationally inadequate if their layouts and spaces do not align with current instructional models.

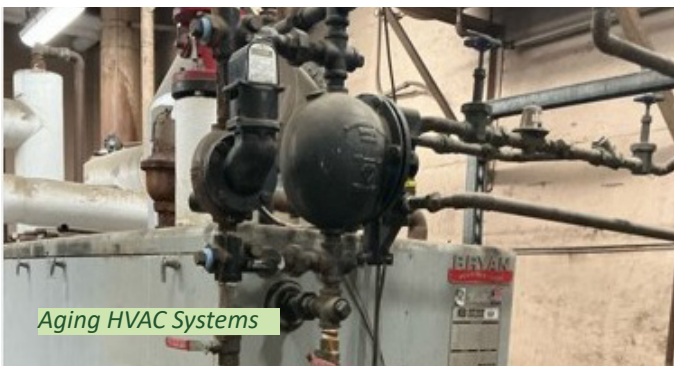
Cooling systems are now essential for safe and effective school operations, not discretionary upgrades. Rising temperatures, longer warm seasons, and more frequent heat events increasingly affect instructional time, student health, and building performance, with many schools experiencing high indoor temperatures during months within the academic year.

Aging HVAC Systems
